Applying Material

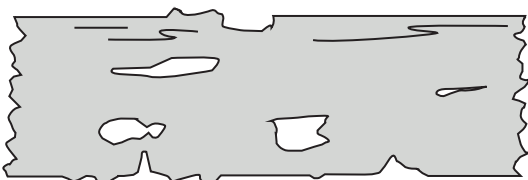
ti14511a

Ragged edges and gaps in line

- Material temperature is too low
- ThermoLazer speed is too fast

- Raise material temperature.
- Wait for change in ambient conditions to remove moisture.
- Reduce ThermoLazer speed.
